Failure analysis of surface-micromachined microengines

Kenneth A. Peterson, Paiboon Tangyunyong, and Alejandro A. Pimentel

Electronic Quality/Reliability Center, Sandia National Laboratories, M/S 1081

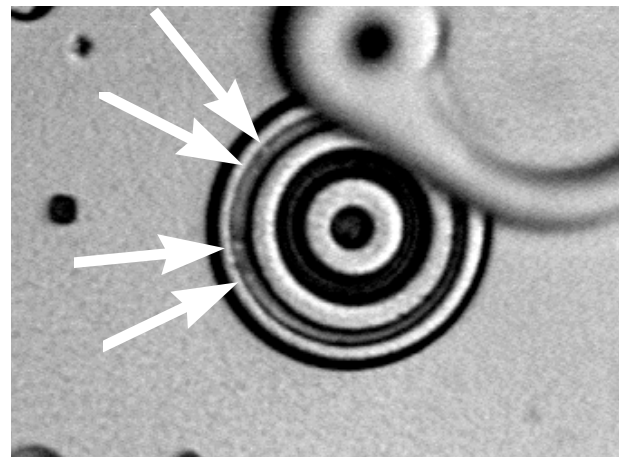
Figure 4. A high-magnification optical image showing wear debris in the gap between the drive hub and drive gear in a failed binary counter.

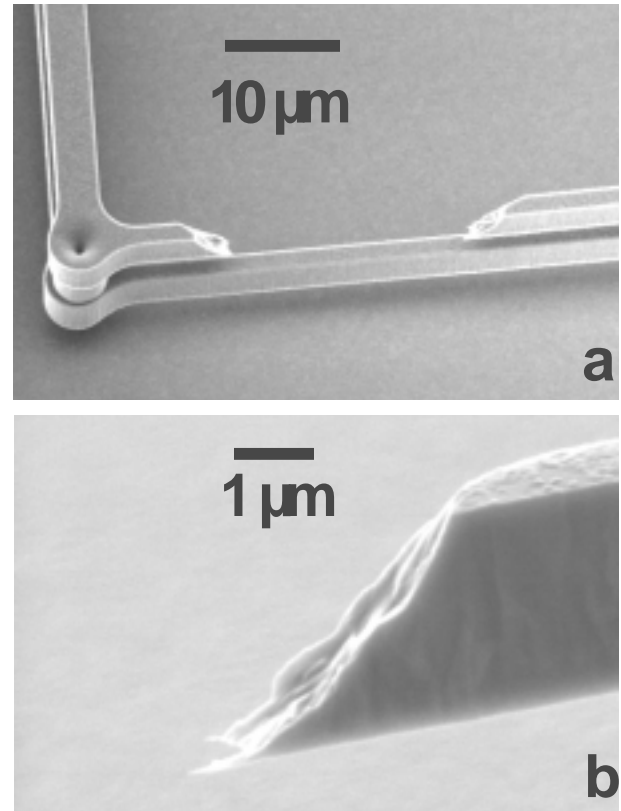
The SEM has been useful for imaging defects at high magnification as well as determining electrical continuity in static and operating microengines. Figure 6 shows a conventional use of secondary electron imaging in the SEM to identify a broken spring element in the comb drive of a failed binary counter.

Figure 6. SEM images of broken upper decks on spring elements.

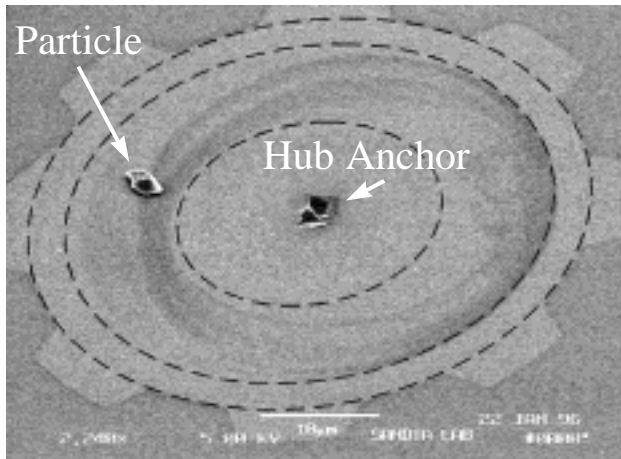
Secondary electron imaging in the SEM was also helpful in identifying the only wear track ever identified on an early version of the microengine, as shown in Figure 7. This wear track is likely to have resulted from an anomaly involving the particle shown at the left in Figure 7. The non-concentric track could only have been made by a gear/hub assembly which had a broken point of attachment to the substrate (shown at center). In another example, Figure 8 shows the wear debris on the intact drive gear. Figure 9 also shows the wear debris in the receiver hole for the drive gear of a failed binary counter after the pin has been fractured and the gear removed.

Figure 7. SEM image of a wear track related to a particle on the substrate. Concentric circles show the relationship of the track to the gear geometry. Note that the hub attachment is fractured (shown at center).

External particulate contamination outside the clean room environment, where reliability testing and failure analysis is conducted, is minimized by the use of transparent covers taped to ceramic packages. Particles could naturally be expected to have a detrimental mechanical or electrical effect on devices where small gaps exist between bearing surfaces or elements with large potential differences. Particulate contamination has been a minor problem and has not received the main attention for this study. The particles which receive attention are those which might be internally generated, or present in spite of a clean room environment. An example of a particle was shown in Figure 7.

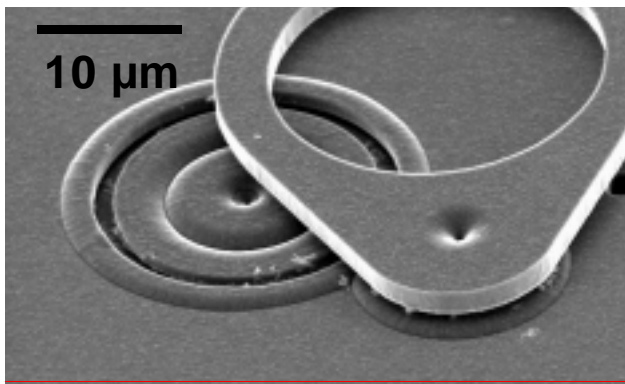
Figure 8. SEM image of a drive pin and a drive gear showing wear debris on the hub of the drive gear.

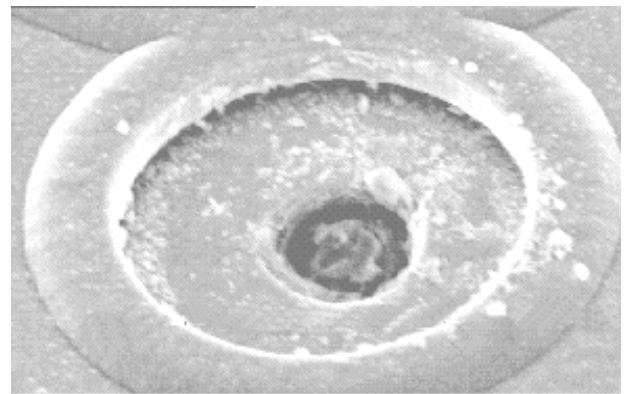
Figure 9. SEM image of wear debris in the receiver hole for the drive gear of a failed binary counter after the pin has been fractured.

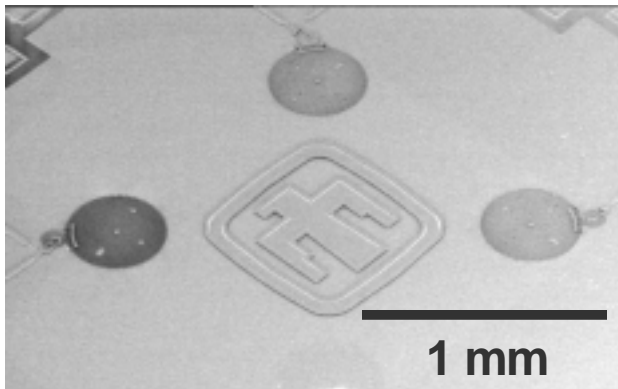
Changes in voltage contrast were observed among several load gears in Figure 12. For example, the left load gear appears dark in Figure 12 (charged positively) compared to the other two. Voltage contrast differences were also observed between the load and the drive gear in each binary counter.

Figure 12. SEM image showing changes in voltage contrast among three load gears. Voltage contrast differences were also observed between the drive gears and load gears in the binary counters.

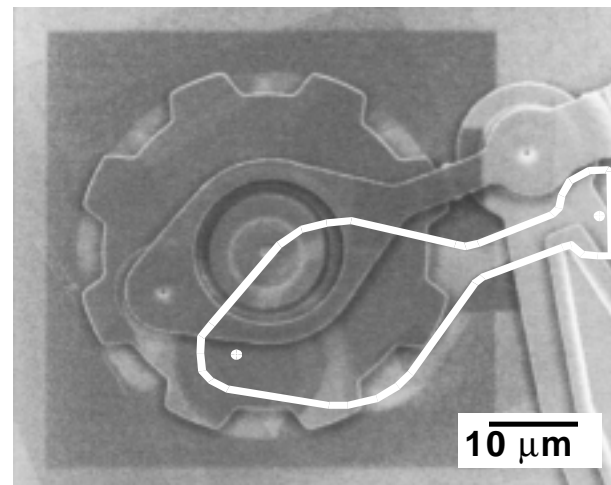
Figure 13. Evidence of charging effect from the ion beam on MEMS structures. The "stuck" position of the X link is outlined in white.

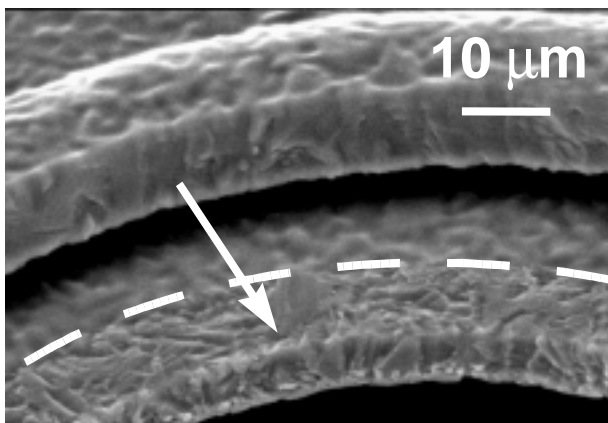
the front and back bearing surfaces of a gear which was operated until failure due to non-uniform rotation. These show a typical result which is the lack of physical indications of wear in the early microengine.

Figure 15. Top and inner surface of gear operated to failure. Arrow and dashed line indicate bearing surfaces.

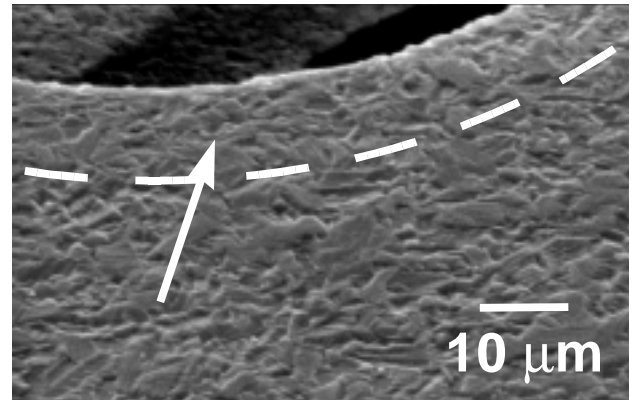
Figure 16. Back surface of gear operated to failure. Arrow and dashed line indicate bearing region.

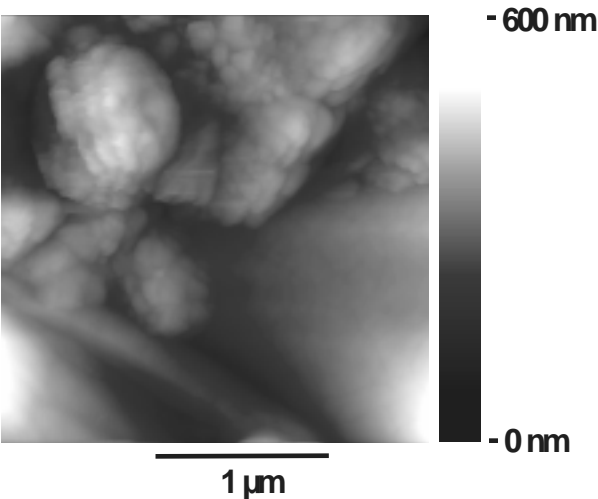
Figure 19. AFM image of wear debris on a drive gear of a failed binary counter.

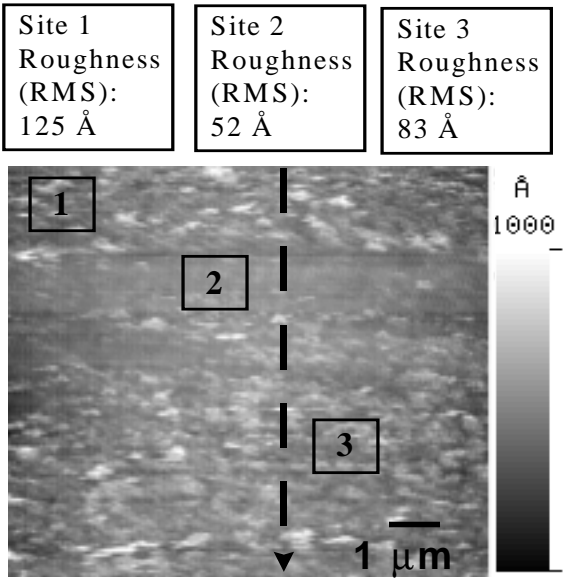
Figure 20. AFM topology image of wear track. The dashed line indicates the position of line scan of Fig. 23.

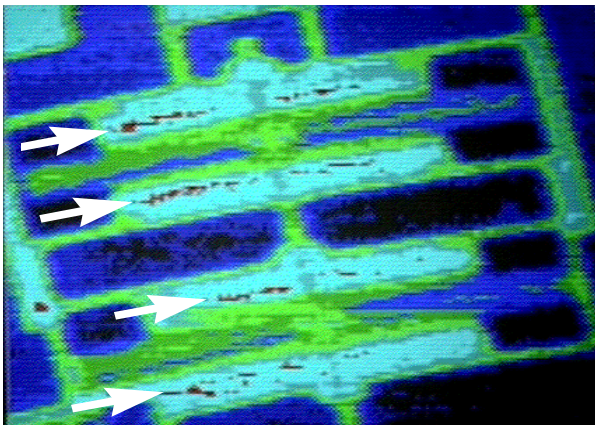
Several operating microengines were examined using an infrared microscope to construct thermal images based on the infrared radiance emitted from the structures. Figure 22 shows thermal image of the X-comb drives of an early version of microengines which was operating, but rotating irregularly with a pause in the rotation cycle. Hot spots (areas where the radiance increased in the image) were found in the X-comb drives. In gray scale, the hot spots appear dark, and are indicated by arrows in Figure 22. No hot spots were found in the Y- comb drives, nor were found in the comb drives of engines operating with smooth rotation.

Figure 22. Infrared image of defective operation in early version of microengine showing hot spots (dark in appearance) in X-comb drive area.

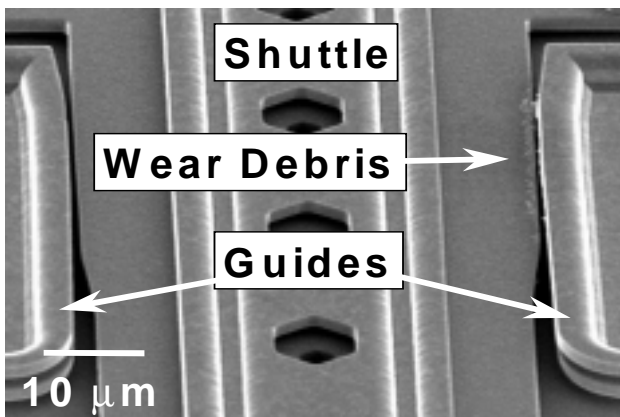
Figure 25. SEM image of wear debris on the shuttle and guide

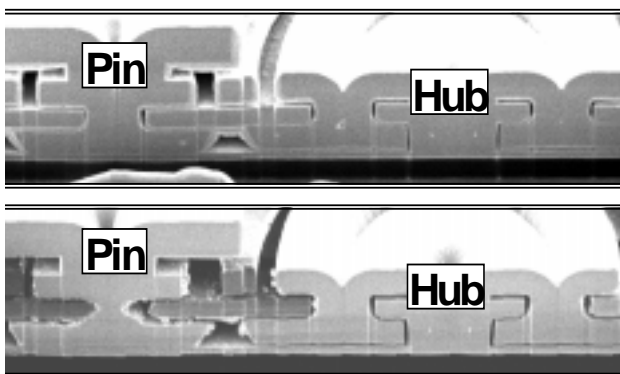
Figure 26. FIB cross sections of the drive gear of a binary counter that was not tested (upper) and one that was tested to failure (bottom). Note that no wear debris was observed in the upper image and severe wear was observed in the lower image.

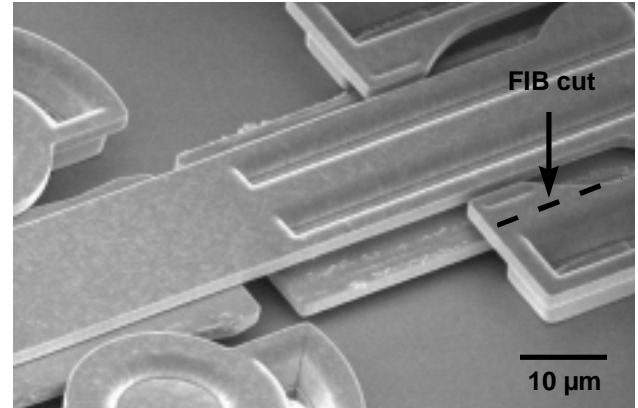
In addition to wear, other failure modes such as friction welding have also been observed in the binary counter. Figure 27, for example, shows the SEM image of the up-down shuttle of a failed binary counter. From visual and SEM inspection, the dimple of the adjacent guide appeared to be stuck to the shuttle. A FIB cut (the location of FIB cut is shown in Figure 27) was then performed to sever the connection between the portion of the guide supporting the dimple and the shuttle. After the FIB cut (Figure 28), the shuttle was able to move and drive the gears to rotate (Figure 29).

Figure 27. Location of FIB cut on the pinned link microengine guide of the up-down shuttle in a failed binary counter.

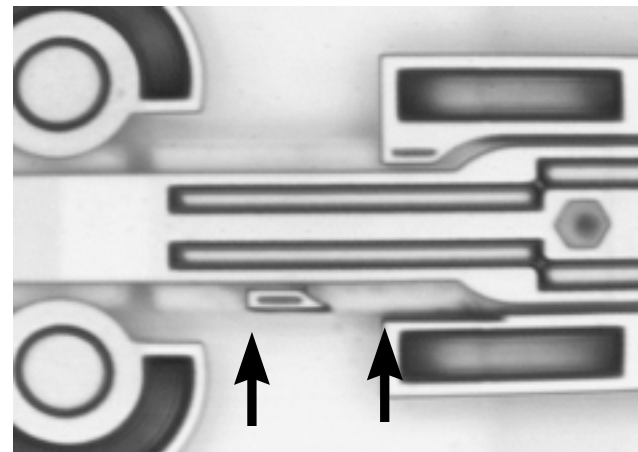
Figure 28. Optical image showing portion of the guide was severed by FIB cut and moved to the left. The FIB cut freed the shuttle from the guide.

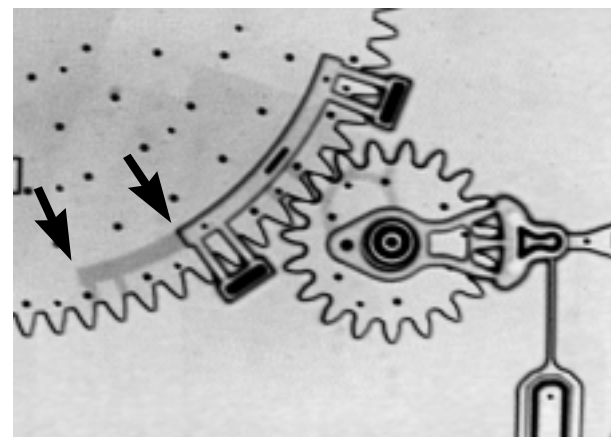
Figure 29. Rotation of load gear shown by arrows and associated FIB stains from initial position of system after portion of the guide was severed.
